Environmental Monitoring Report

Semi-Annual Report

Project Nos: 43322-012, 45094-001, 46260-002, 50211-001
(January – June 2019)

TIM: Road Network Upgrading Project

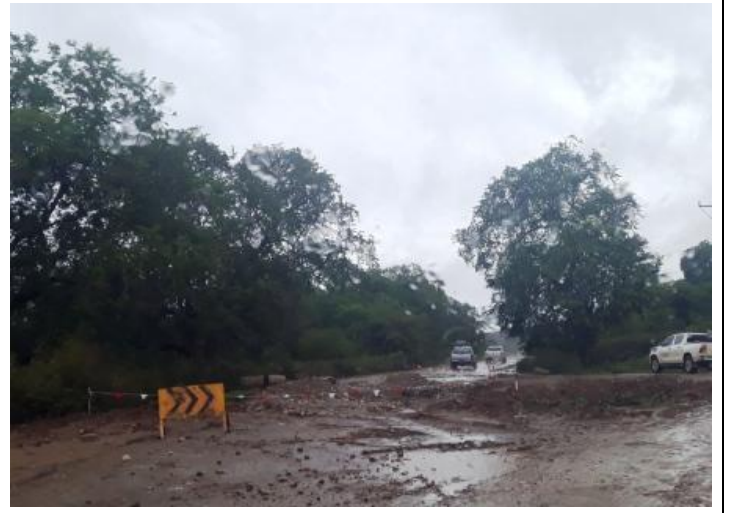
March 2019, installation of road signages to warn the commuters on the road obstruction and direct to the detour road.

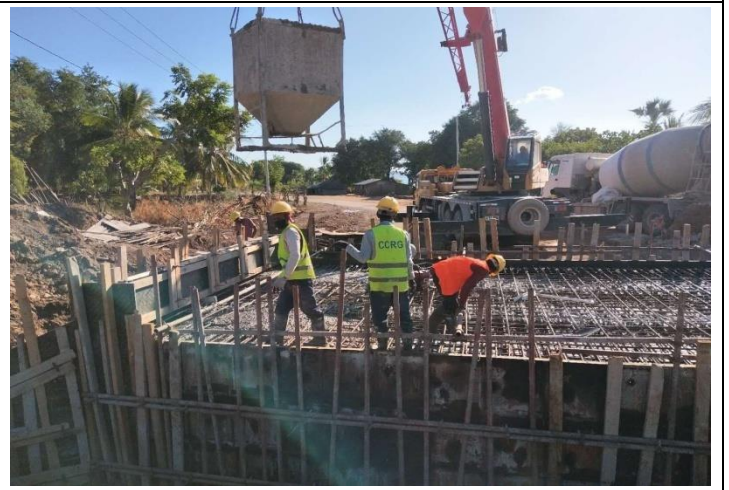
May 2019 Construction of RCBC at Sta. 116+700 PPE compliance.

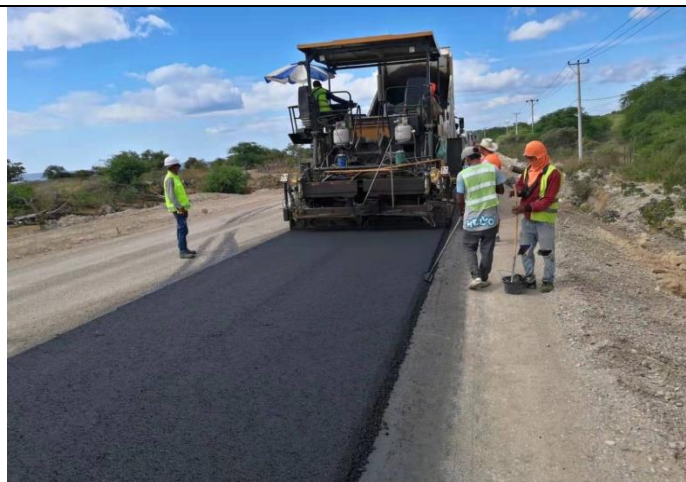
June 2019. Asphalt Paving Sta. 115+360 R/S workers are provided with PPE.

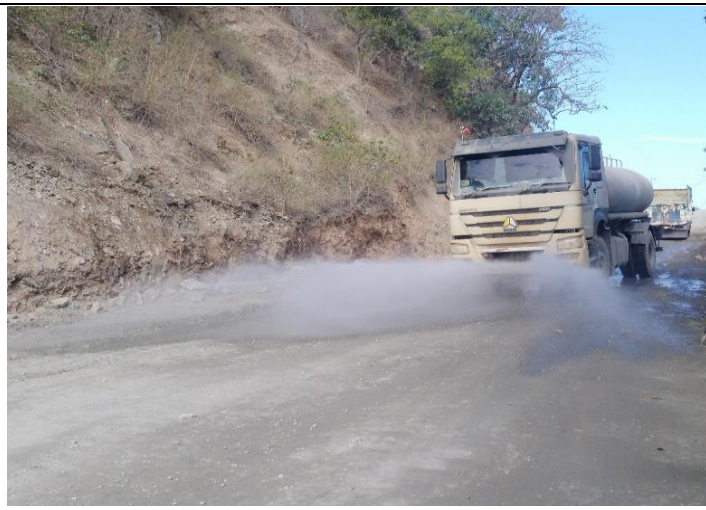
January 2019 (Km 51 – Km 53) dedicated water truck in this section to control the dust three times per day as per EMP and CPAR 002.

CPAR 006	Dust Nuisance from bare road surface along the community neighborhoods. Plan the watering schedule with special attention to residential areas to water the road three times per day in line with EMP and environmental license's conditions. 28 July 2017 The issue closed out immediatelyand monitores	Approx Km 104 LS No PPE for workers. Workers working on the slope protection structure are not provided with PPE. Dusty working area. Children around the working area. 28 July 2017 Continous monitoring for the compliance	Dust nuisance impact on the dense settlements, active working areas and visibility for passing vehicles. Minimize dust by regulars spraying water to maintain acceptable visibility for road users. 27 september 2017 Continous monitoring for the compliance	Contractor's Environmental Management Plan (CEMP). • PISC to assist the Contractor with updating the CEMP with location approvals, mineral licenses and progress on environmental licenses for approval by the PISC and endorsement by PMU. • Summary and	Attachment of ADB letter 11 of April and 7 of June. Griavance redress Mechanism. USAID concern (Conservation International), Marine life at Dili rock (Km 8+749 - 9+980) 13 June 2018 Consulant letter 5 July 2018; Consultant proposal letter (ref Nos. RNUP-UT-CWYC-502) is submitted to

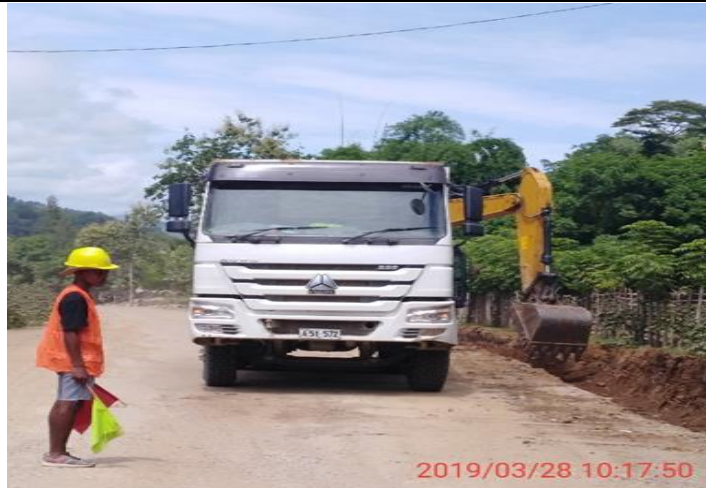
March 2019 (Sta. 97+610) Flagmen assigned to control the traffic during the line ditch excavation work.

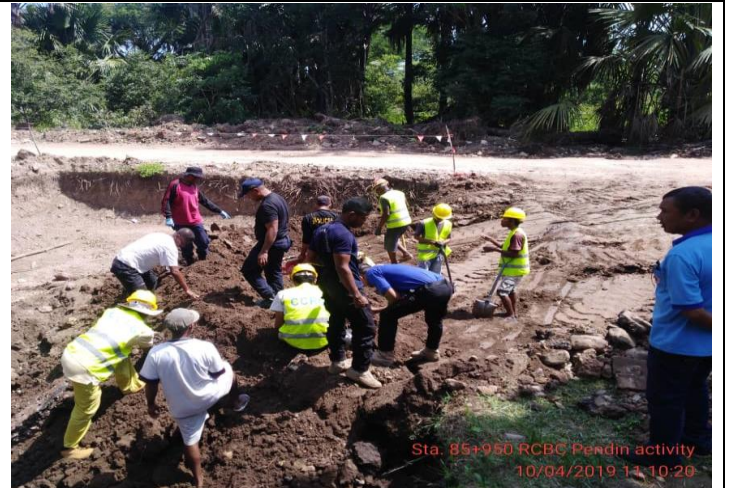
10 April 2019 (Sta. 85+950) Culvert work temporarily stopped as human remains found on site. Local authority and police informed.

107. During the excavation of Box Culvert at Sta. 85+978, found some human remains and bones. The work activity immediately stopped and the Bobonaro Municipal Government was informed. The National Forensic Police the did the investigation and transfere the remains.

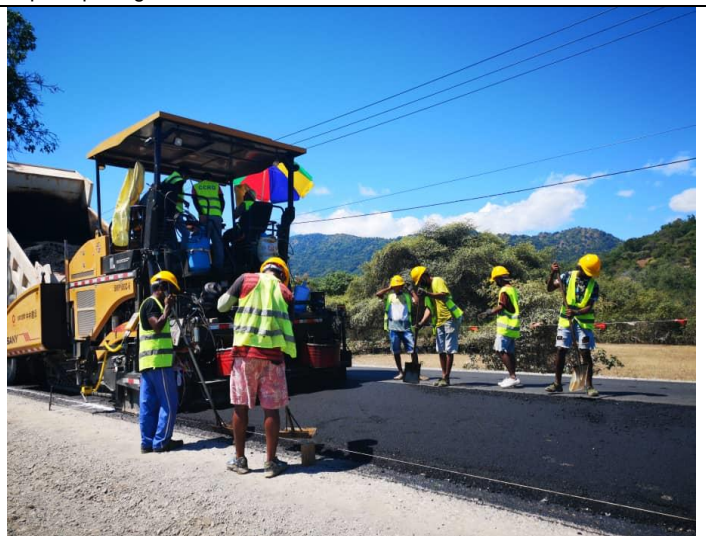
May 2019 (Sta. 108+800) worker are not provided with PPE during the asphalt paving work.

CPAR 010	<p>Partial or inappropriate PPE noted at number of work sites. • Provide PPE (hard helmet, reflective vest, gloves, dust mask and safety</p>	<p>Dust Control / watering schedule. • If no rain in past 5 hours, water spraying must take place at least three times per day as required in the</p>	<p>Dust control / Watering schedule . Water spraying must take place at least three times per day as required in the</p>		<p>Sea wall construction. • Silt Fence. The KEI has concluded that the silt fence is unnecessary as the works will be done at low tide. 'Sea Wall</p>

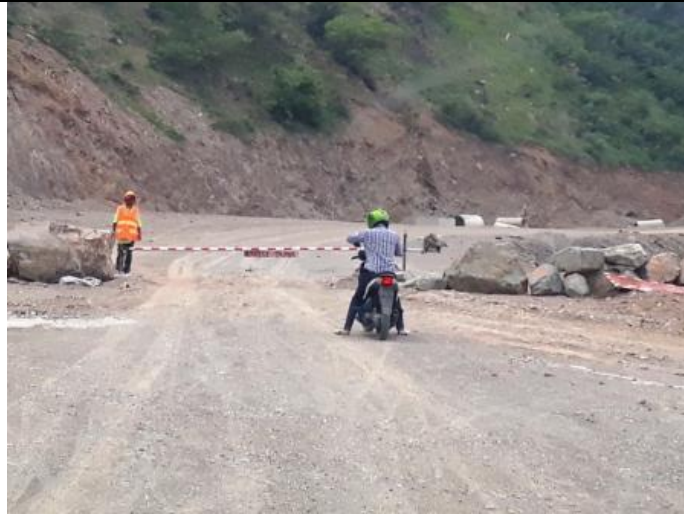
4 January 2019 effective traffic control (guard post and the guardman) controlling the public to not enter construction site at shortcut section.

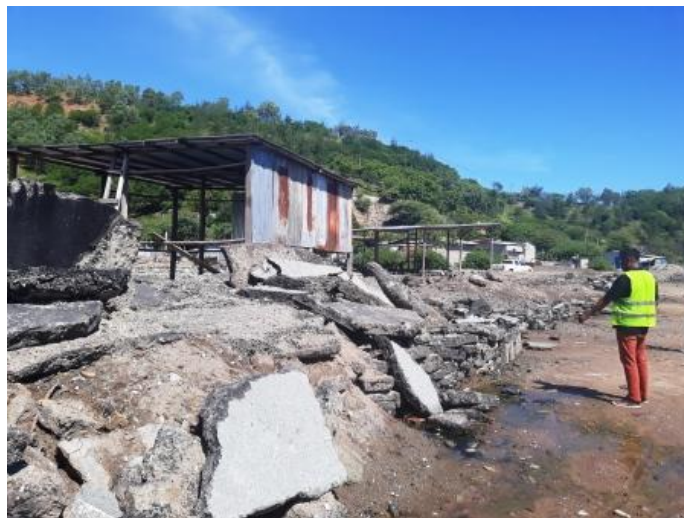
1 March 2019 PMU inspection confirmed the dumping of asphalt material at Tasitolu Lake.

84. To solve the issue, PMU issued **CPAR 012** required immediate action no later than 22 March 2019 to remove the dumped asphalt materials and restore the Tasitolu Lake to its original condition. The contractor removed the dumped asphalt materials at Tasitolu Lake on 16 May 2019 and checked, verified and reported by PISC on the CPAR respond letter to PMU on 20 May 2019.

CPAR	RNUSP P1 MAN-LAC	RNUSP P2 LAC-NAT	NR1UP DIL MAN	NR1UP MAN BAU	RNUP-AF TAS-TIB	RNUSP-AF BAU-LAU	RNUSP-AF MKAM	RNUP-AF AIP-BAZ
		Monitoring Reports (June 2018 to September 2018). It is noted that out of 22 SI, 2 SI were complied with the action required, 7 SI with partial complied and 13 SI with not complied. 22 January 2019	the construction limits and by seaside vegetation in close proximity of the beach. 22 January 2019 Continous monitoring for the compliance		Safety patrol should be introduced to supervise the implementation of Traffic Management Plan. 22 January 2019 Continous monitoring for the compliance			
CPAR013					This is to notify Contarctor the letter from Secretary of State for Environment No.Ref:47/MCAE/GSEA//2019 date 18 February 2019 concerning the dumping of existing asphalt at the Tasitolu Lake Protected Area. Tasitolu Lake is declared as the Protected Area based on the Decree Law 05/2016 National System of Protected Area to protect areas representing all ecosystems, cultural, history and all critical habitats for endemic and other species that are protected under national law as well as for migratory species found in Timor-Leste. 15 March 2019 Issue close out on May 2019. The dumped asphalt removed.

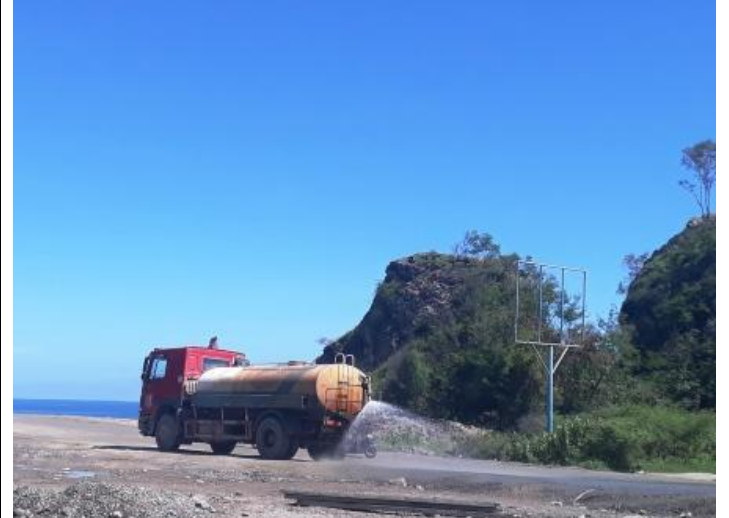
1 March 2019 PMU inspection, the contractor continue water the road to minimize the dust.

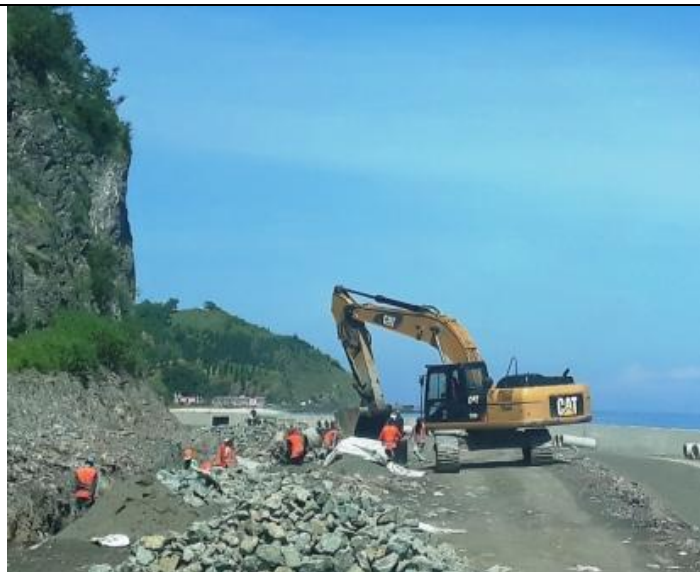
April 2019, workers are equipped with PPE constructing the line drain at Sta 10+200 L/S

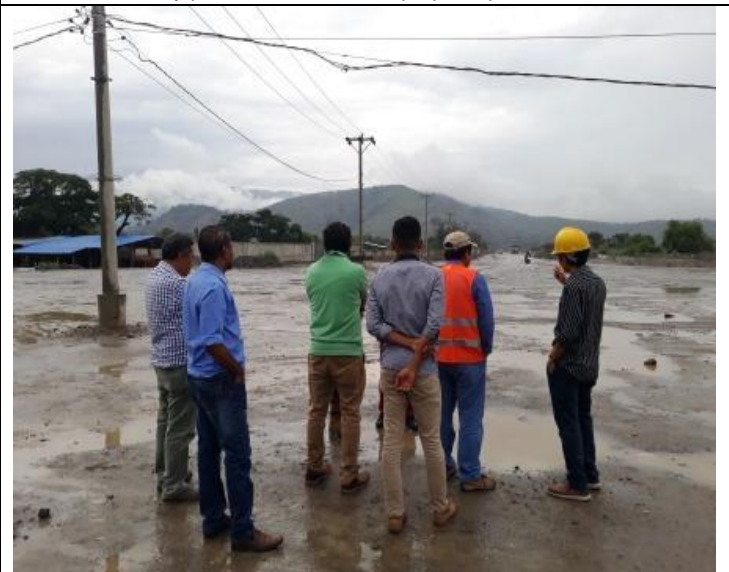
May 2019, Joint site inspection PMU-MPW-PISC-Contractor to identify affected electricity poles and discuss the proper reposition.
