2862/63/64 BAN(SF): Greater Dhaka Sustainable Urban Transport Project

Bus Rapid Transit (BRT), Airport-Gazipur

Package 2, Engineering, Procurement and Construction Management (EPCM)

SEMI-ANNUAL ENVIRONMENTAL MONITORING REPORT No.4: JANUARY – JUNE 2018

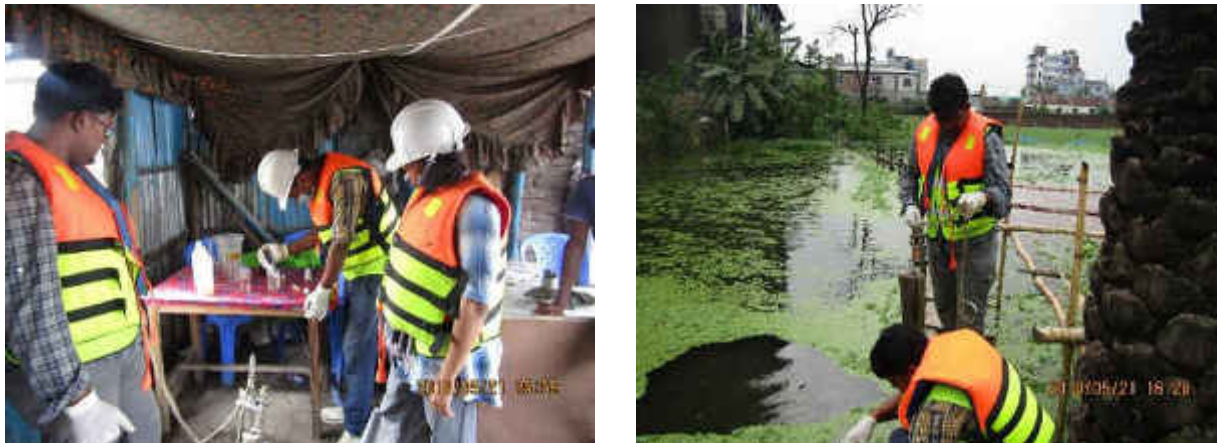
Figure II.1: Surface Water Sample Collection and On-site Testing

57. Surface Water samples were collected from two project influenced locations on 21st May, 2018 for the second routine sampling. (Figure II.1).

58. All samples were collected in plastic sampling bottles, kept in an ice cooler, after necessary stabilization/fixing, and analyzed within 72 hours of being collected. Only the samples for oil & grease were collected in glass bottles. Tests have been carried out in the Laboratories of the DPHE, and the University of Dhaka. The laboratory test results are given in Appendix 10. A summary of the Test Results of surface water sampling of the Contract influenced area is given at Table II.3.

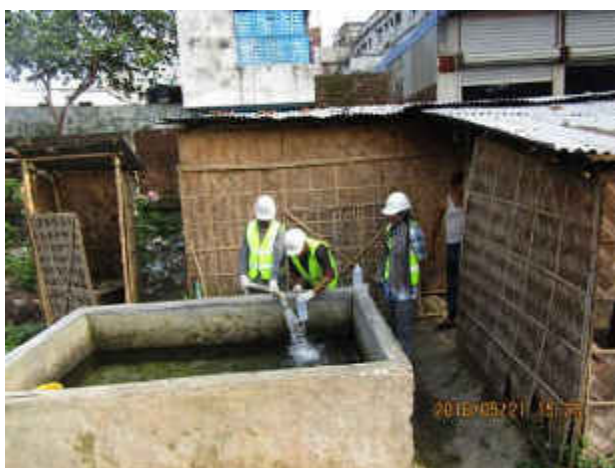
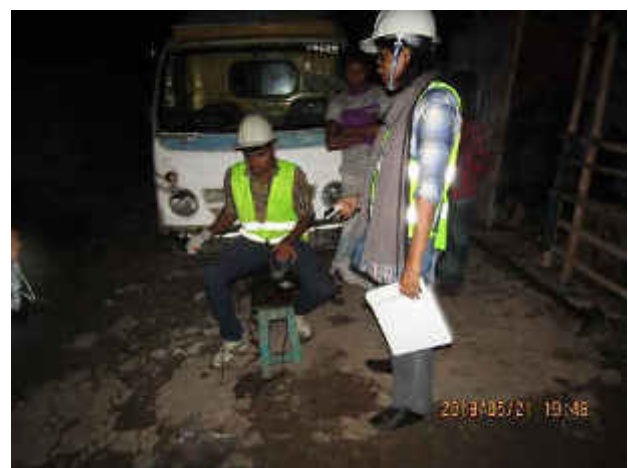
Figure II.2: Groundwater Sample Collection and On-site Testing

60. Groundwater samples were collected from three Contract influenced locations on 21st May 2018 for the second routine sampling (Figure II.2).

61. All samples were collected in plastic sampling bottles, kept in an ice cooler, after necessary stabilization/fixing, and analyzed within 72 hours of being collected. Tests were done at the Laboratories of the DPHE, and the University of Dhaka. The laboratory test results are included in Appendix 10. A summary of the Test Results of surface water sampling of the Contract influenced area is given at Table II.4.

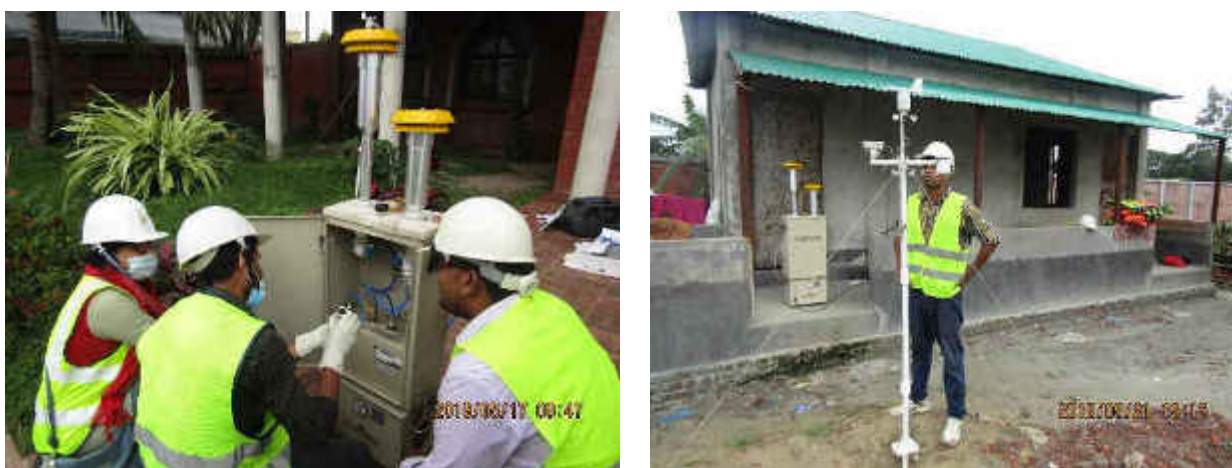
Figure II.3: Air Quality Monitoring at Project Site

65. The air quality sampling was performed at and around the Contract location from 17th May to 21st May, 2018 for the second routine sampling (Figure II.3.). The laboratory test results are given in Appendix 10 and are summarized in Table II.5 and II.6.

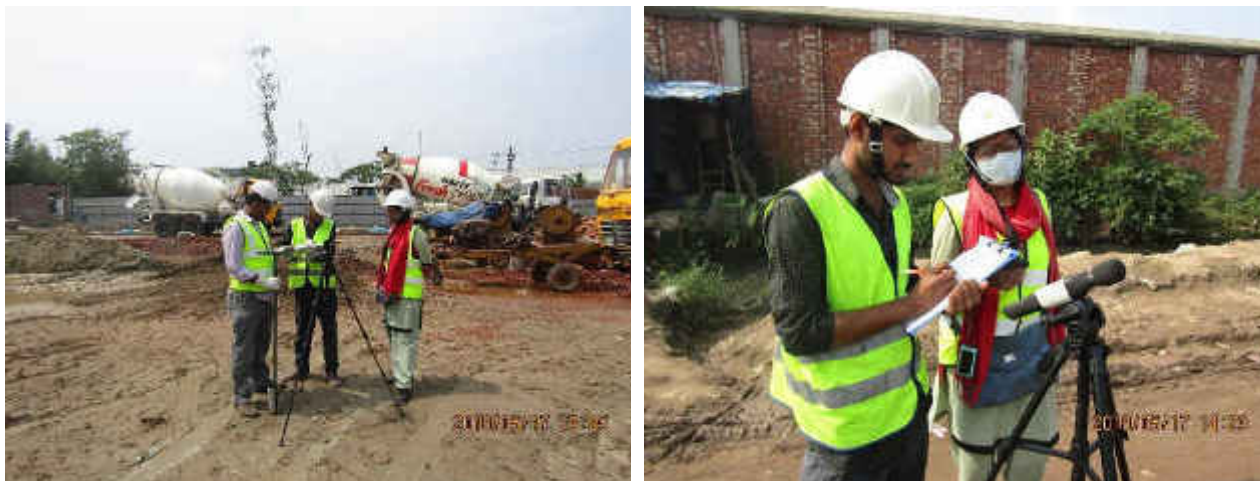
Figure II.4: Noise Level Monitoring at Day and Night Time in the Project Area

68. The Noise Level Measurements were taken at Contract influenced locations from 17th May to 21st May 2018 for the second routine sampling (Figure II.4). The laboratory test results are given in Appendix 10 of this report.

69. Noise level measurements taken during the day and night time are summarized in Table II. Noise measurements at each location were taken continuously for 15 minutes during the day and for 15 minutes during the night.

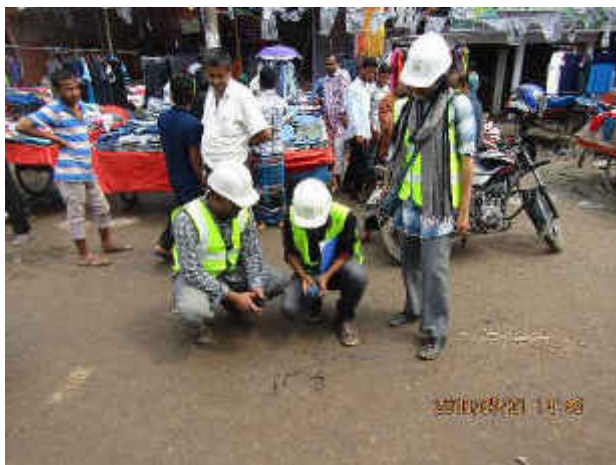
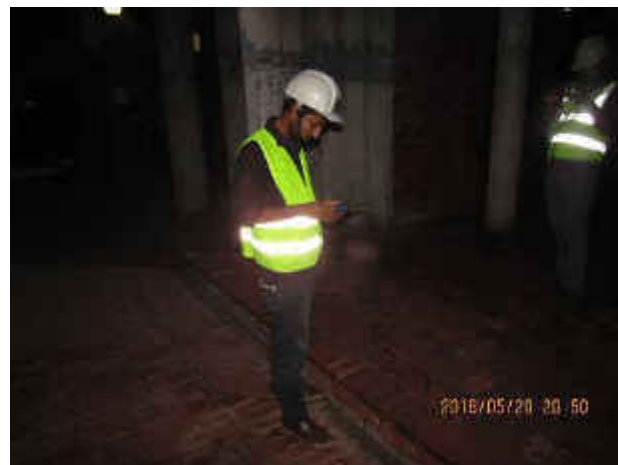
Figure II.5: Vibration Level Measurement

71. Vibration Levels were monitored at the Contract influenced locations from 20th May to 21st May 2018 for the second routine sampling (Figure II.5). The results of the Vibration Levels are shown in Table II.8. The laboratory test result is given in Appendix 10 of this report.

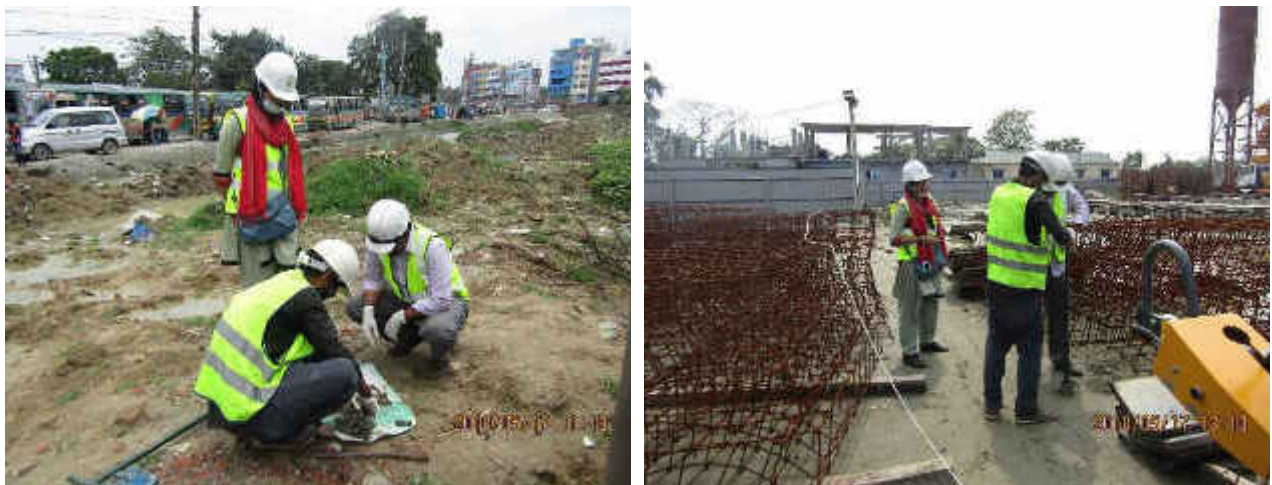
Figure II.6: Soil Sampling at Project Site

74. Soil samples were collected from all the Contract influenced locations on 17th May 2018 for the second routine sampling (Figure II.6). Test results of the soil analyses of the Contract influenced area is given in Table II.9. The Laboratory test results are included in Appendix 10 of this report.

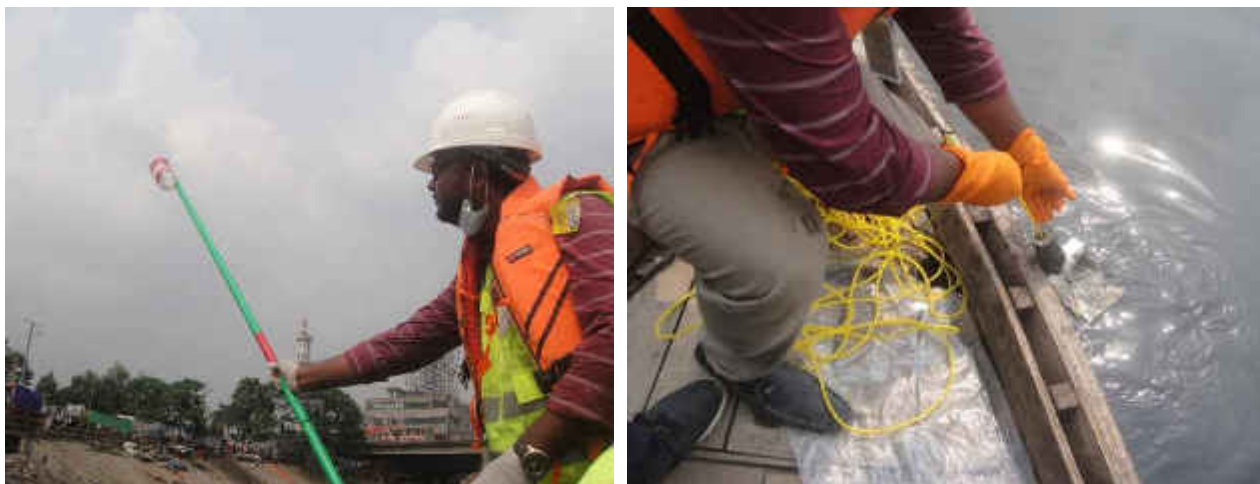
Figure II.7: Surface Water Sample Collection

79. For this contract the surface water sample were collected from 50 m U/S and 50 m D/S of the Turag River. The overall water is too much unaesthetic with bad smell. Industrial waste and effluent are dumped and discharged respectively into the river. However, these waters are used regularly for different activities of the slum dwellers such as washing, cooking, bathing etc.

80. The baseline surface water samples were collected from the Contract location on 15th May 2018 (Figure II.7) and the collected samples were sent to the Bangladesh Council of Science and Industrial Research (BCSIR) for the testing of several parameters. The results of the surface water quality monitored at the two locations have been summarised in Table II.10.

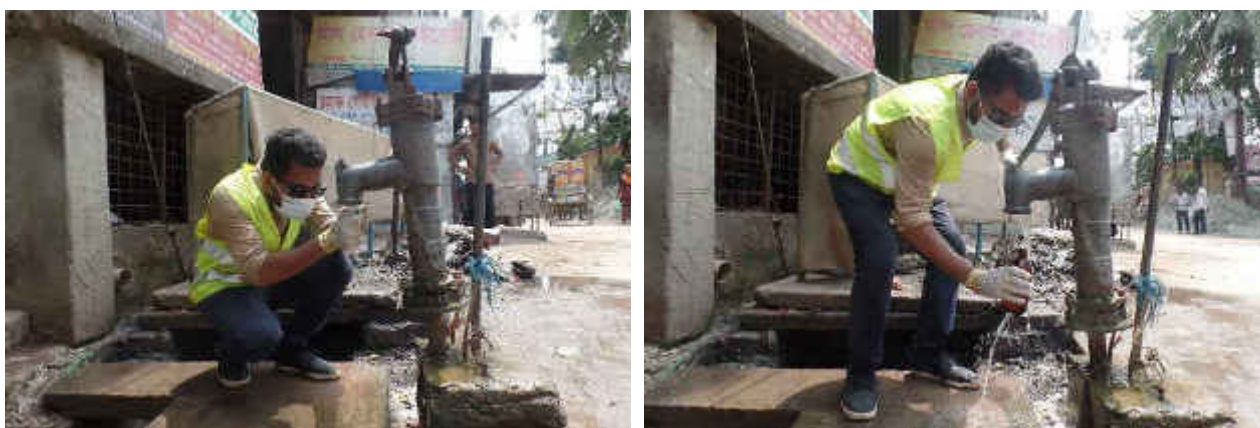
Figure II.8: Groundwater Sample Collection

83. The groundwater sample are collected from the Contract location on 15th May 2018 (Figure II.8) and the collected sample was sent to the Bangladesh Council of Scientific and Industrial Research (BCSIR) and International Centre for Diarrhoeal Disease Research, Bangladesh (icddr,b) for testing of several parameters. Results of the groundwater sampled at the two sites have been summarised in Table II.11.

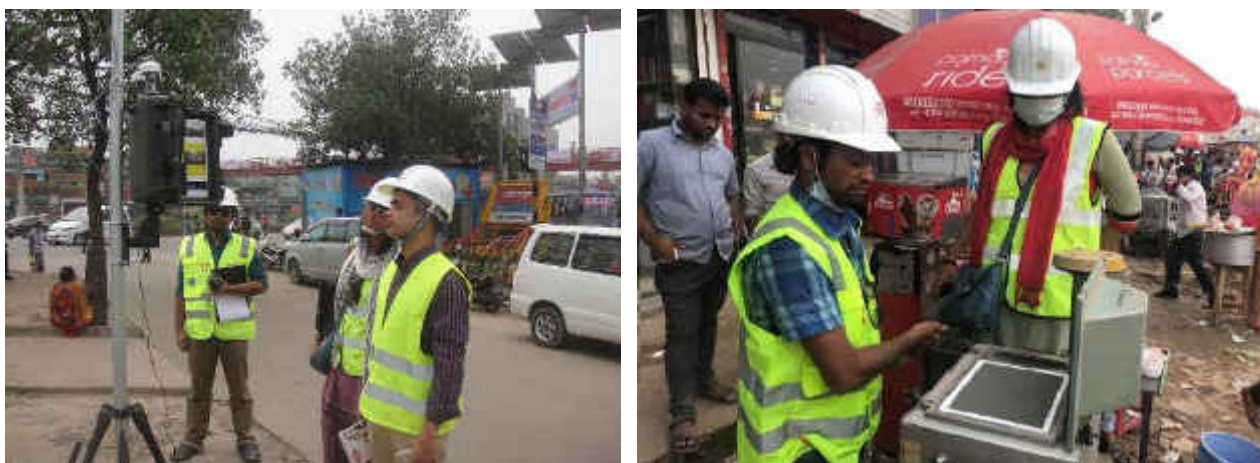
Figure II.9: Air Quality Monitoring at Project Site

86. Air quality measurements were carried out at the C02 site on 14th and 15th May, 2018 (Figure II.3).

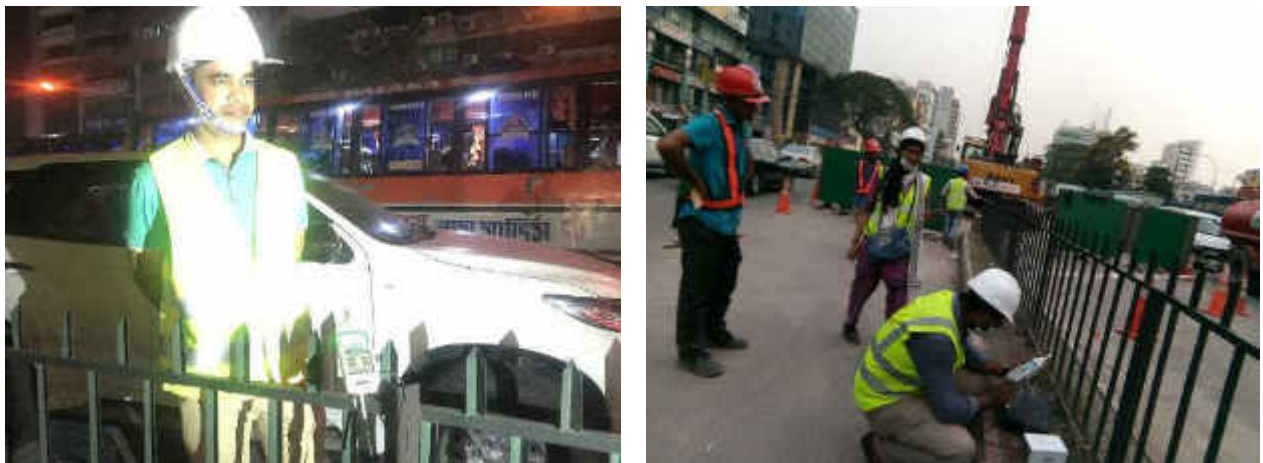
Figure II.10: Noise Level Monitoring at Day and Night Time in the Project Area

90. Noise level data was collected both day and night time at the construction site on the 14th and 15th May, 2018 (Figure II.10). The results of the noise level monitored along with details of the sampling locations have been summarised in Table II.13.

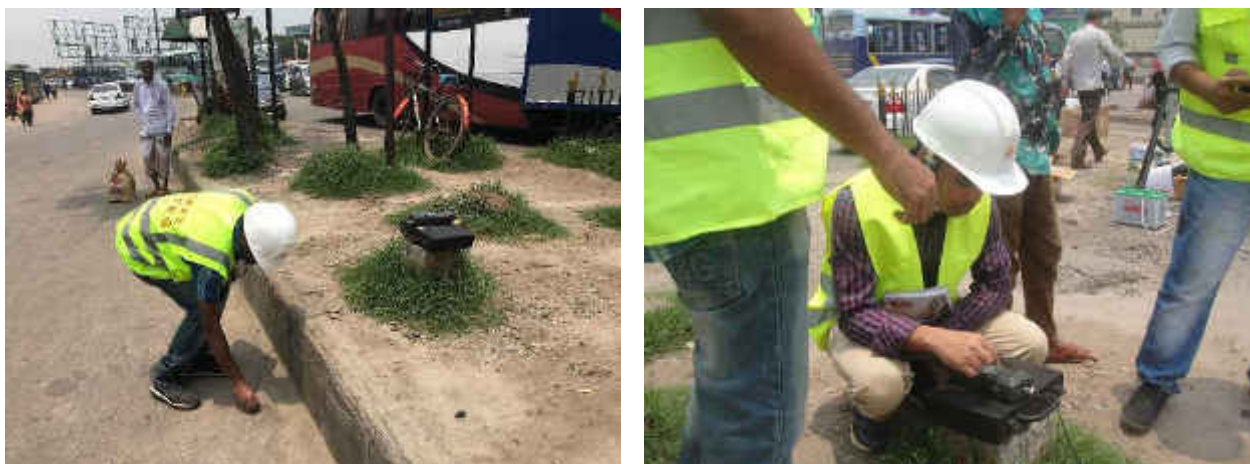
Figure II.11: Vibration Level Measurement at Project Site

92. Vibration caused by the construction activities was expected to be a major problem in the construction site of the elevated flyover site. Vibration measurement was conducted during day and night time at the construction site on 14 and 15 May, 2018 (Figure II.11). The result of the vibration measurement has been summarised in Table II.14. The details of the results are given in Appendix 10 of this report.

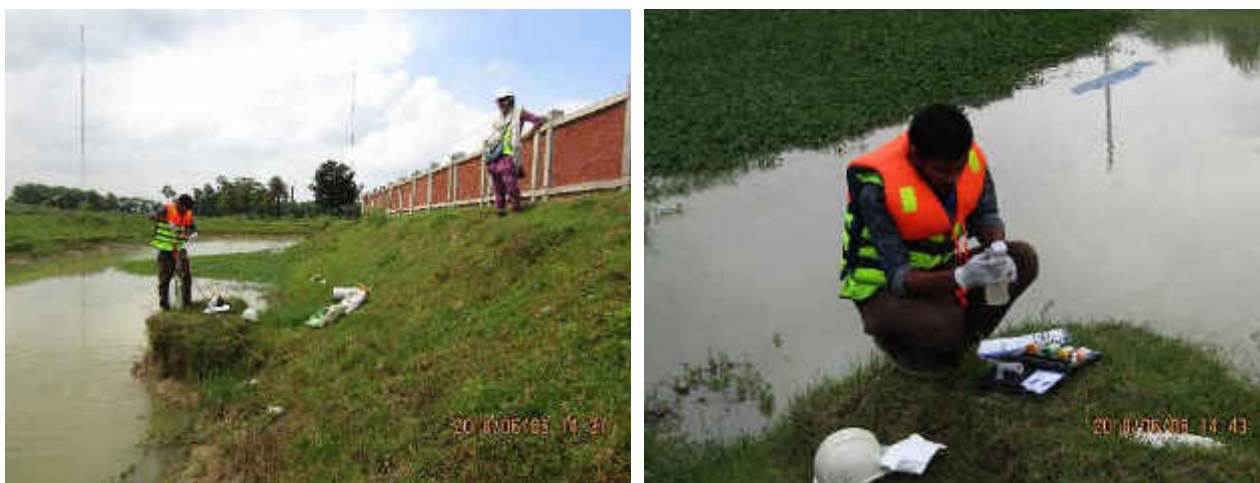
Figure II.13: Surface Water Sample Collection and On-site Testing

100. Surface water samples were collected from the Contract location on 6th June 2018 (Figure II.13) and the collected samples were sent to the Department of Public Health Engineering (DPHE) and University of Dhaka (DU) for the testing of several parameters. The results of the surface water quality monitored at the C04 location have been summarised in Table II.16.

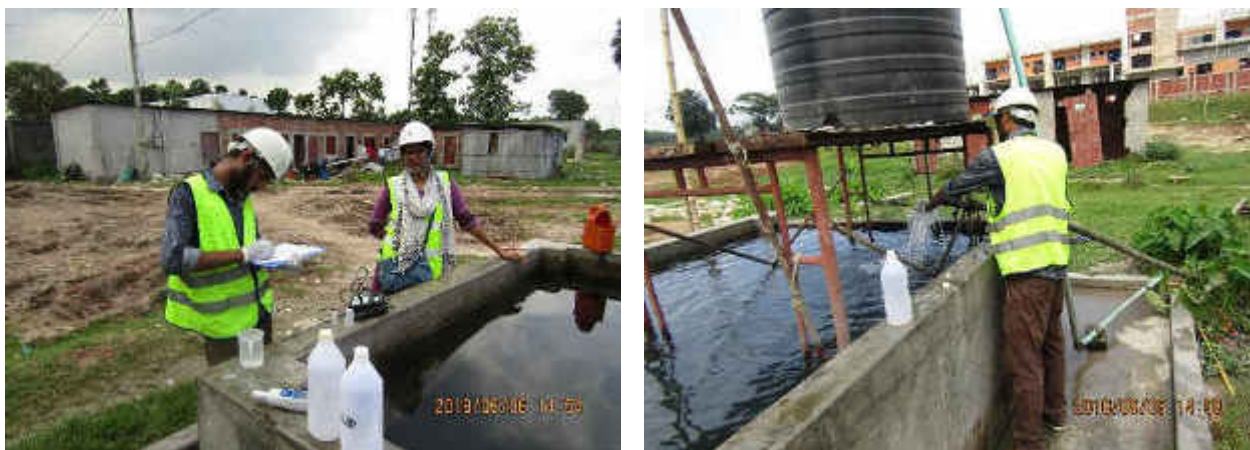
Figure II.14: Groundwater Sample Collection

103. The groundwater sample was collected from the Contract location on 6th June 2018 (Figure II.14) and the collected sample was sent to the Department of Public Health Engineering (DPHE) and University of Dhaka (DU) for the testing of several parameters. Results of the groundwater sampled at the C04 site have been summarised in Table II.17.

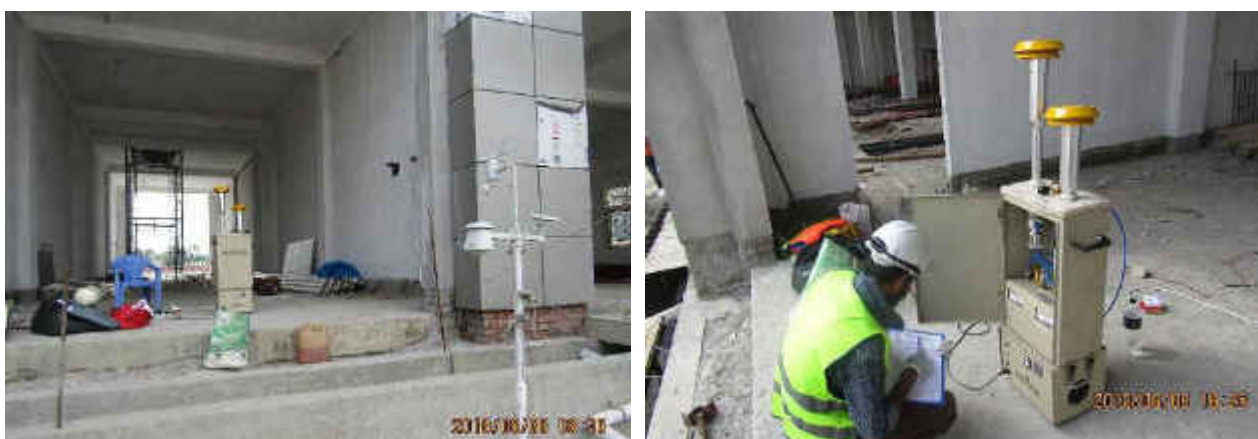
Figure II.15: Air Quality Monitoring at Project Site

107. Motor vehicles are the major source of particulate matters (PM) pollution. Most of the PM pollutants (greater than 80%) come from diesel-run vehicles. In the low-lying agricultural land surrounding Dhaka city, hundreds of brick kilns which contribute to high levels of particulate matter operate during the dry months November– April. Dispersal of pollutants depends upon factors like prevailing wind direction and other weather conditions, atmospheric stability, height of the source. Air quality measurements were carried out at the C04 site on 6th June, 2018 (Figure II.15). The results of the air quality sampled at the C04 site have been summarised in Table II.4.

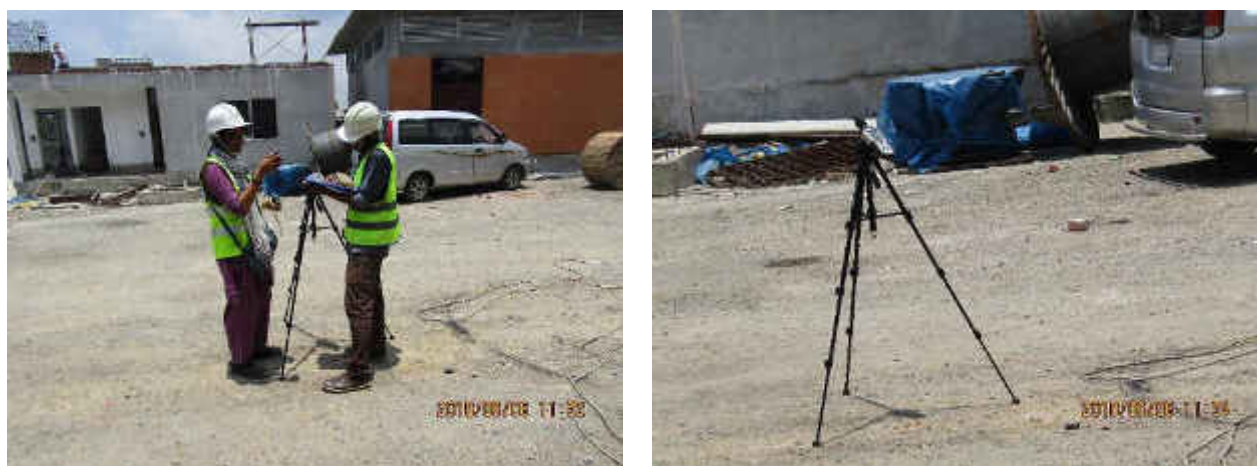
Figure II.17: Noise Level Monitoring at Day Time in the Project Area

110. Noise level data was collected during day time only at the construction site on the 6th June, 2018 (Figure II.17). The results of the noise level monitored along with details of the sampling locations have been summarised in Table II.19.

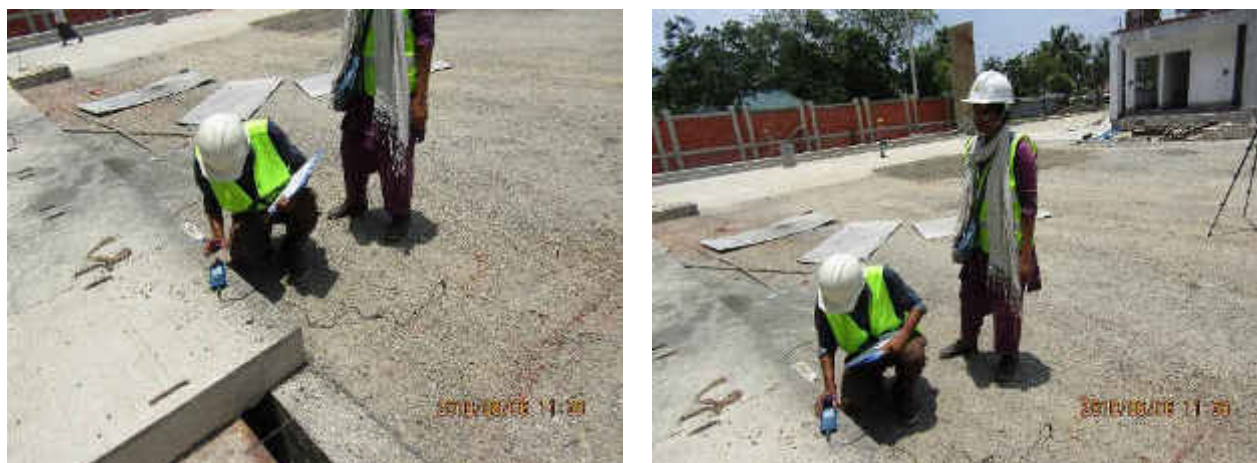
Figure II.18: Vibration Level Measurement at Project Site

112. Vibration caused by the construction activities was expected to be a major problem in the construction site of the bus depot. Vibration measurement was conducted during day time at the construction site on the 6th June, 2018 (Figure II.18). The result of the vibration measurement has been summarised in Table II.20. The details of the results are given in Appendix 10 of this report.

113. The above results show that the Maximum Velocity was 0.91 mm/s, the maximum acceleration was 0.1 m/s² and the maximum displacement was 0.084 mm. Again, the Mean value for velocity was 0.241 mm/s, for acceleration was 0.002 m/s² and for displacement was 0.011 mm.

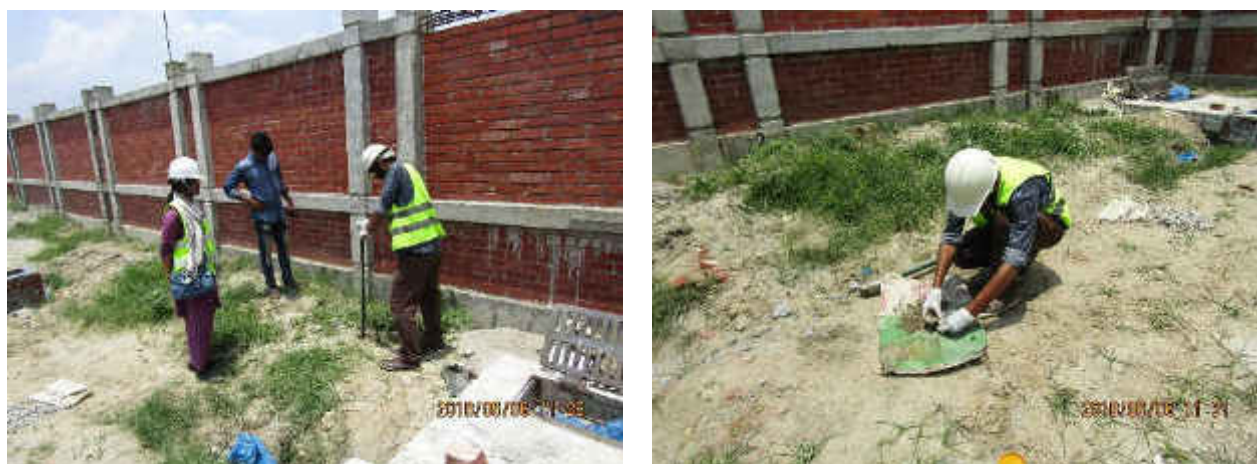
Figure II.19: Soil Sampling at Project Site

University Laboratory within 72 hours of collection. The result of the soil tests along with details of the sampling location has been summarised in Table II.21.

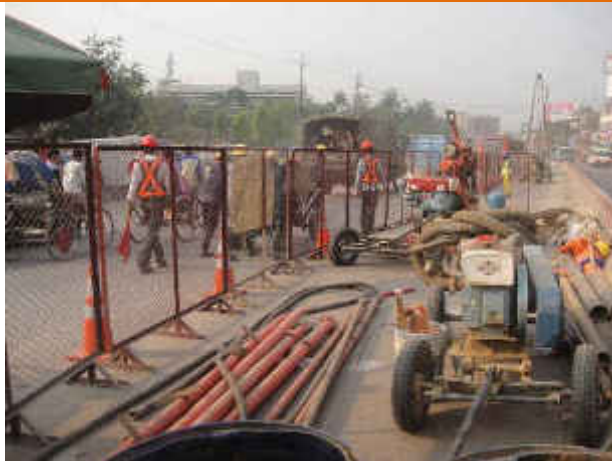
Road and Traffic Maintenance (CO2)

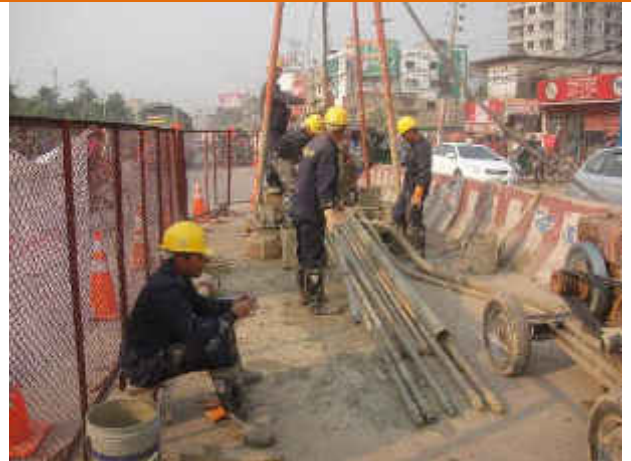
Labourers wearing PPE (CO2)

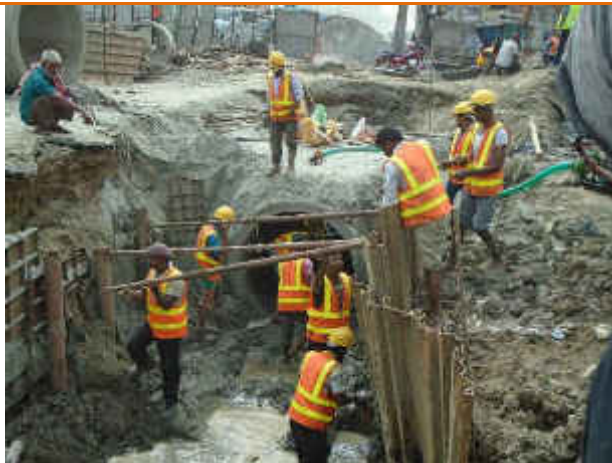
General View of Works in progress (CO1)

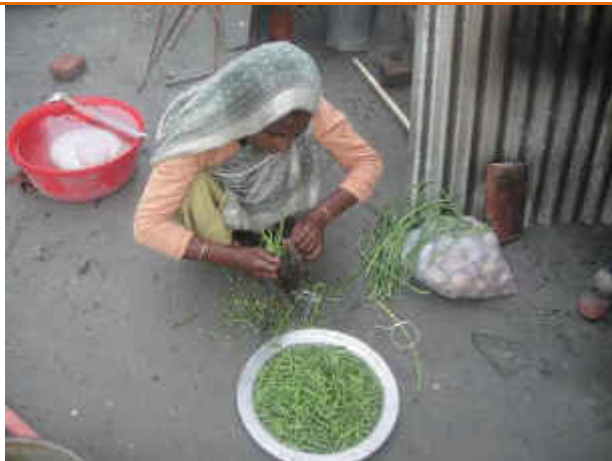
Cooking arrangements for the labourers (CO1)

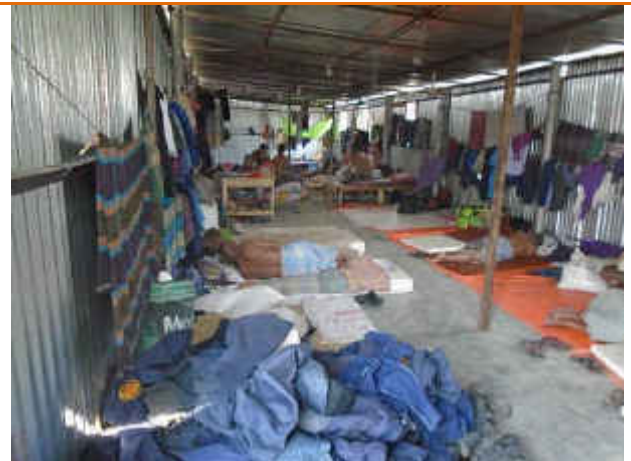
Living arrangements for the labourers (CO1)

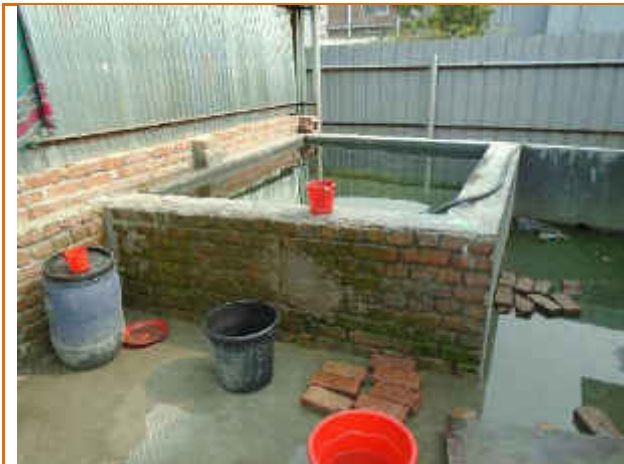
Water supply arrangements for the labourers (CO1)

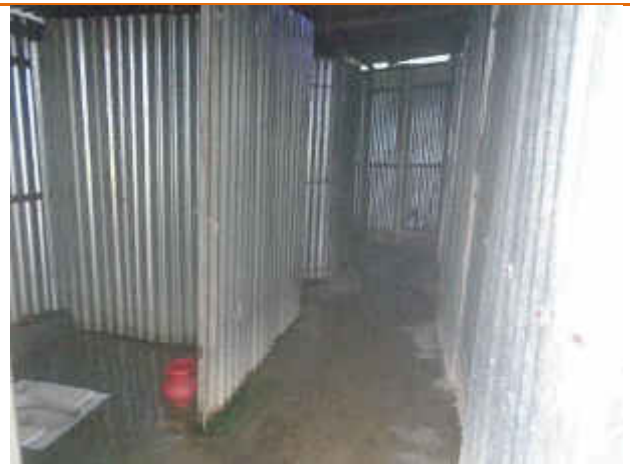
Sanitary Latrines for labourers (CO1)

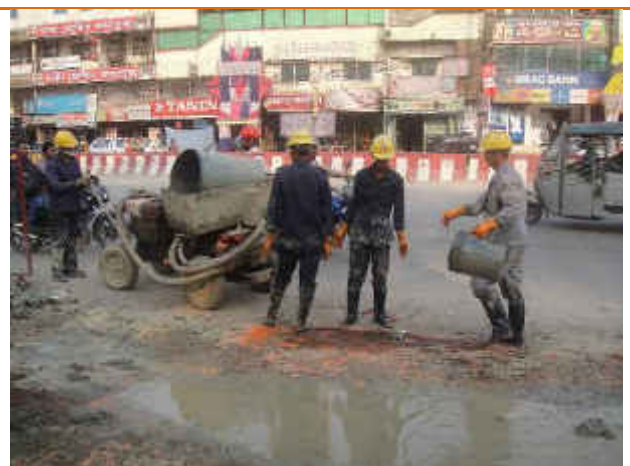
General View of Works in progress (CO2)

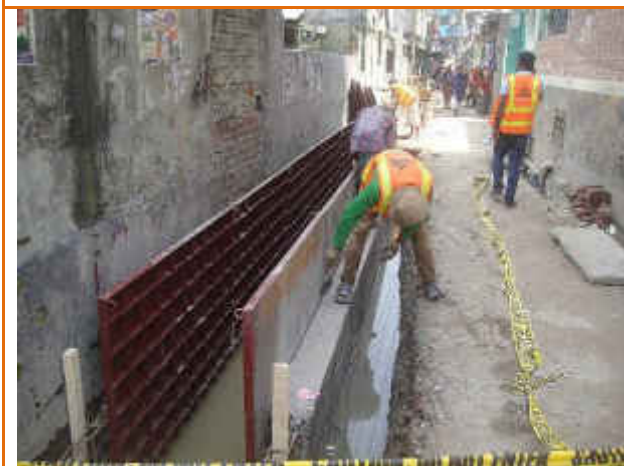
General View of Works in progress (CO3)

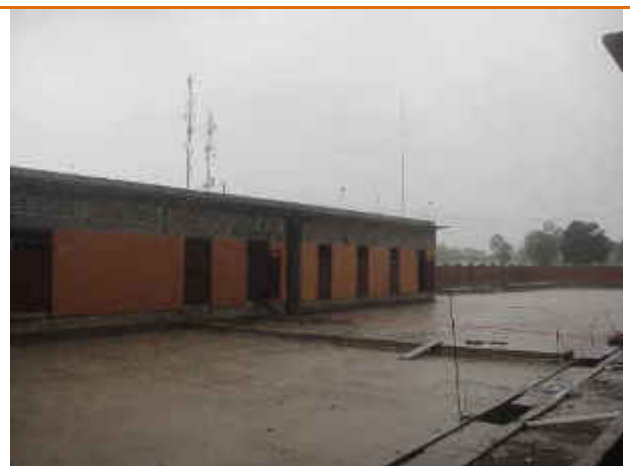
General View of Works in progress (CO4)
