GLACIER LAKE OUTBURST FLOOD (GLOF) MITIGATION PROJECT, LUNANA, BHUTAN

Technical Mitigation Measures Thorthormi Outlet

BRAUNER, M., LEBER, D. & HÄUSLER, H.
with contributions of
PAYER, T. & AGNER, P.

**Department of Geological Sciences, University of Vienna,
Geocenter, Althanstrasse 14, A-1090 Wien, Austria
Vienna, October 2003**

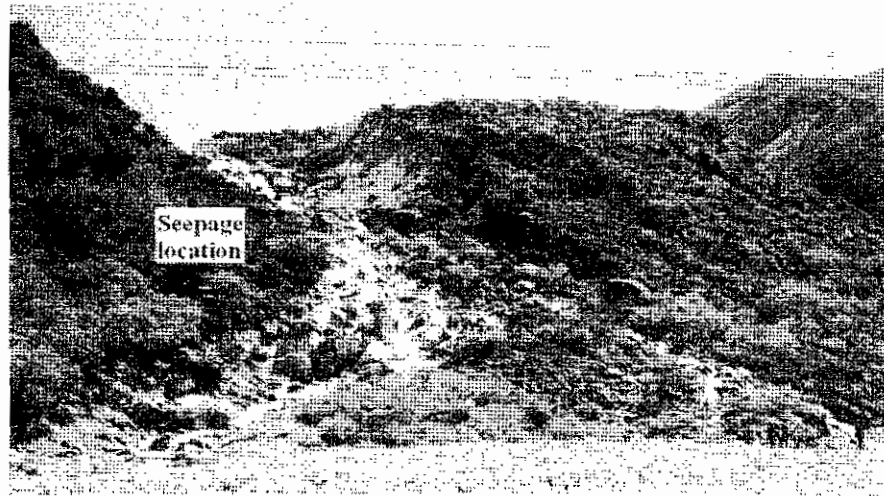
Figure 3.4: Detailed overview of the Thorthormi spillway channel in summer 2001. Active sideslope erosion and big boulders stabilizing the channel can be seen.

As Figures 3.3, 3.4 and 3.5 show, in 2001 the active spillway channel of the Thorthormi glacier is actively eroding into the moraine body. At that location the outer side of the 30 to 60 m high moraine body shows an average slope angle of 1:4, the inner side shows a more gentle slope of 1:10 (see Figure 3.4 and 3.5).

The spillway channel is very steep and shows big residual boulders (up to a diameter of 7 m) which can not be transported by water force. These residual boulders stabilise the spillway channel. Whereas the upper half of the channel is actively eroding, the lower part shows a lower slope gradient and can therefore be considered as stable.

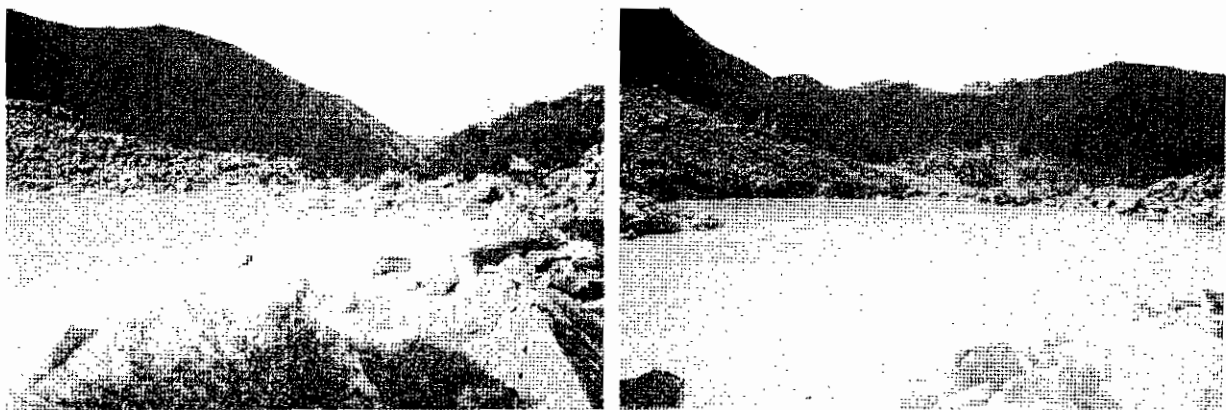
Figure 3.5: Left: Lake outlet at the crest of the inner terminal moraine. Right: Lake inlet. On both sides features of the unstable hummocky moraine are visible, probably underlain by dead ice.
